Intel[®] Xeon[®] E3-1200 v4 Processor Family

Specification Update

July 2020

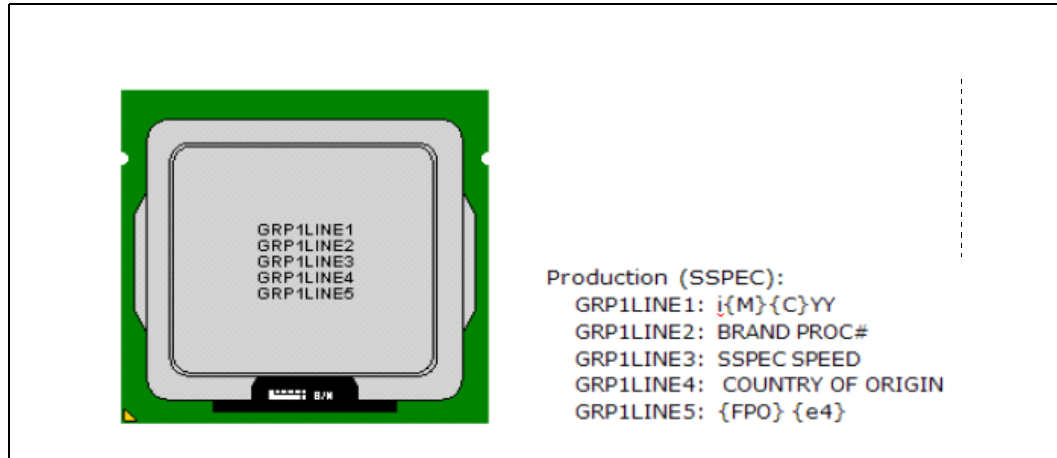
Figure 1. Intel® Xeon® Processor E3-1200 v4 Product Family LGA Top-Side Markings

The processor stepping can be identified by the following component markings.

Pin Count: 1150

Package Size: 37.5 mm x 37.5 mm
